Stony Creek whole of system litter investigation & management prioritisation

Catchment Background Report

Technical Report No:31

June 2020

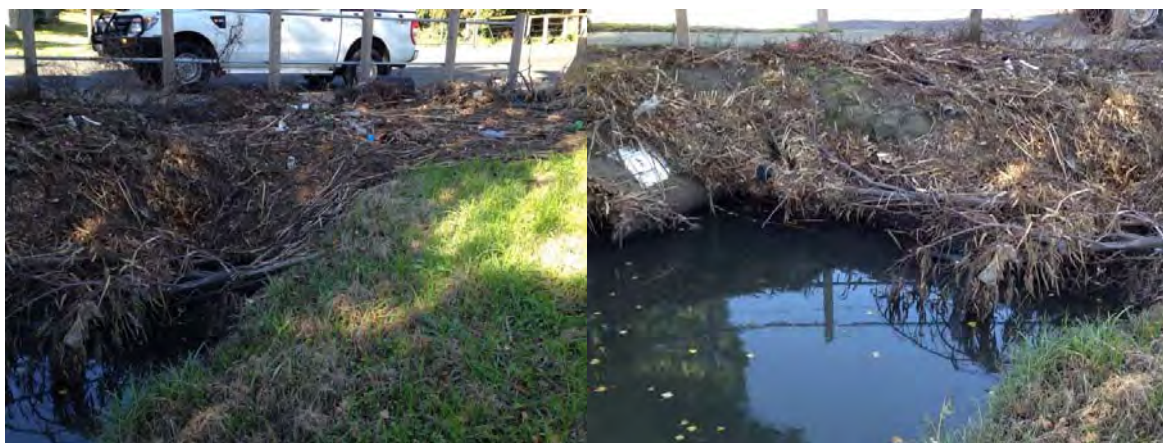
Figure 5: Small litter items and accumulated vegetation litter at Waratah St which was removed in 2017 by Melbourne Water. Source: Melbourne Water.

This site is characterised by small litter items and vegetation debris (Figure 5).

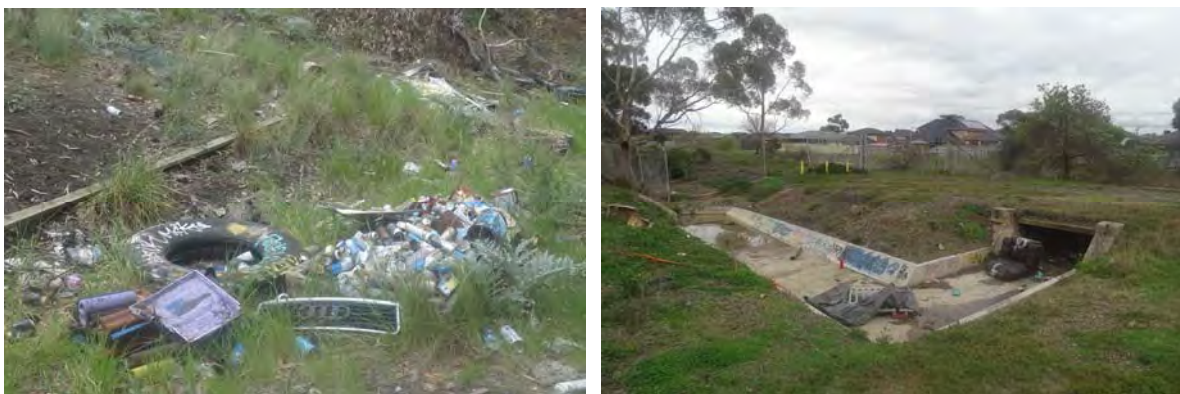
Figure 6 Litter accumulation at the VicTrack freight yard includes spray cans, car tyres, and items of furniture.

Community members identified the VicTrack freight yard as a hotspot for discarded and illegally dumped litter which could be swept into Stony Creek during storms. The litter here includes spray cans, wood and bricks from construction zones, and furniture Figure 6. The litter in this area accumulates at the northern embankment where the freight yard crosses Stony Creek, and east of the eastern train line to Newport (south of Sunshine Road).

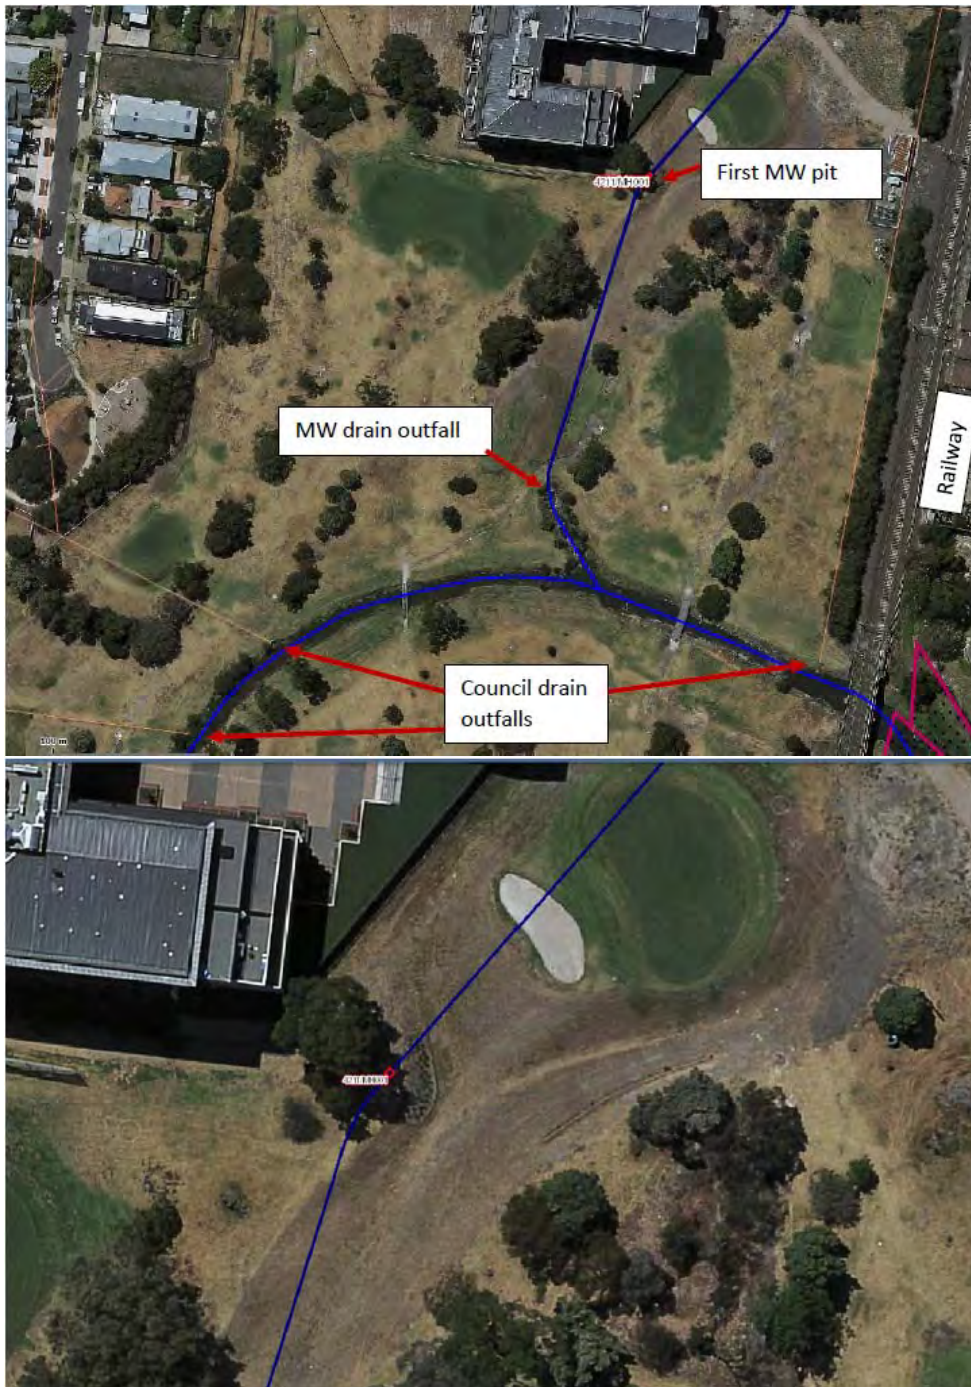
Figure 9: Location of Melbourne Water main drain at Yarraville Golf Course (top), and close-up of manhole location at Yarraville Golf Course (bottom).

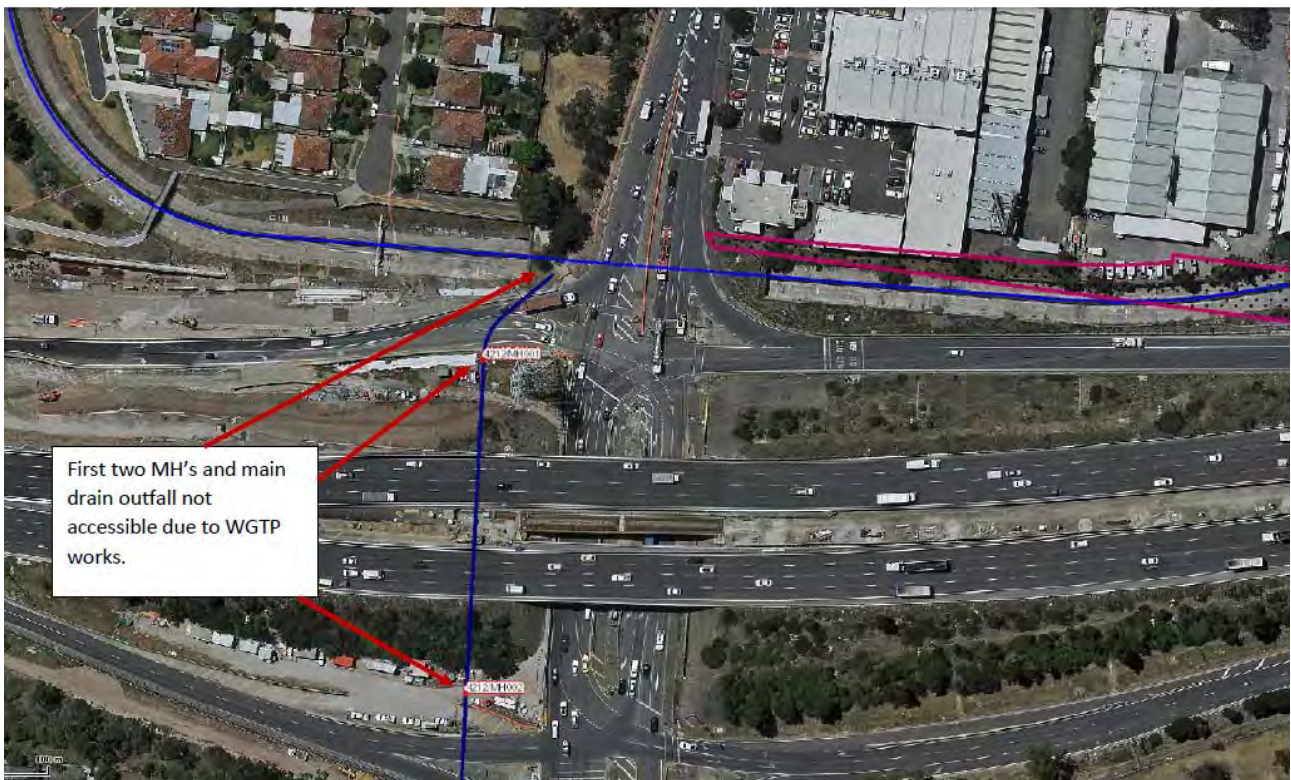
Figure 10 Map of manholes and drain outfall on Williamstown Rd, beneath the Westgate Freeway overpass.

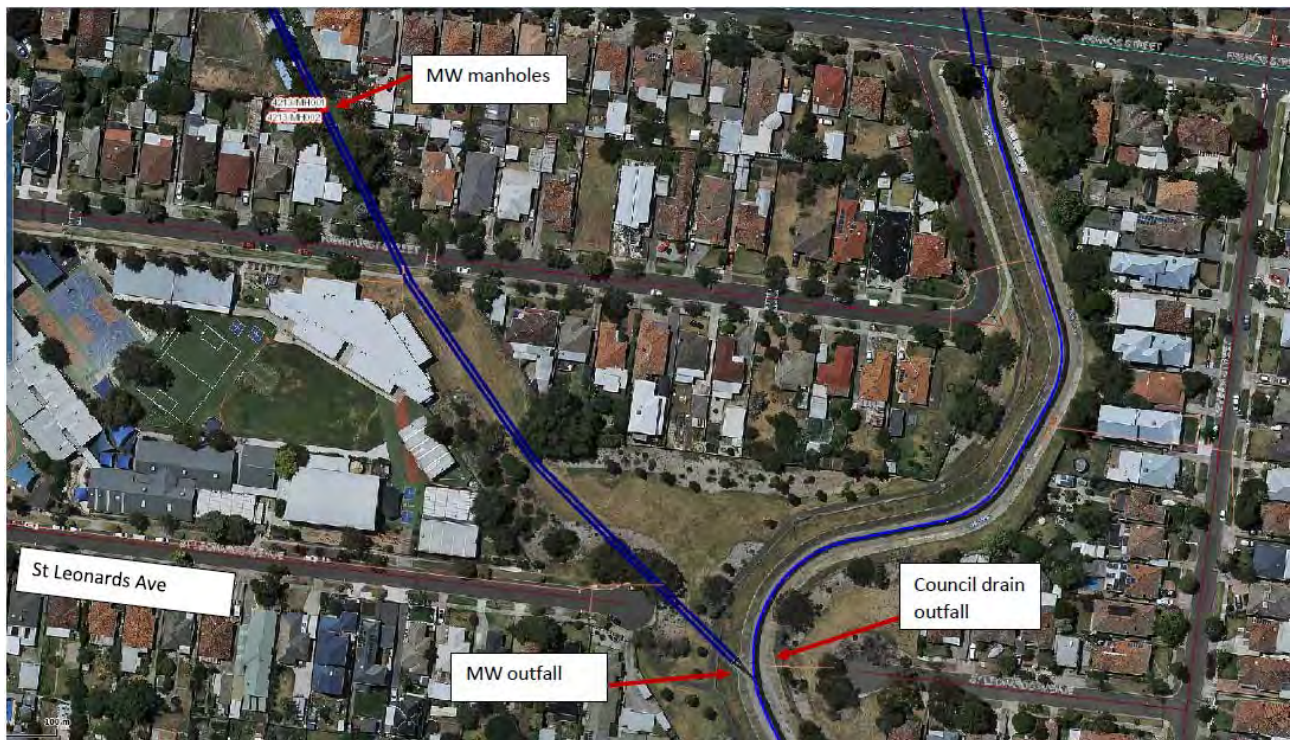
Figure 11 Map of manhole and drain outfall at St. Leonard's Ave.

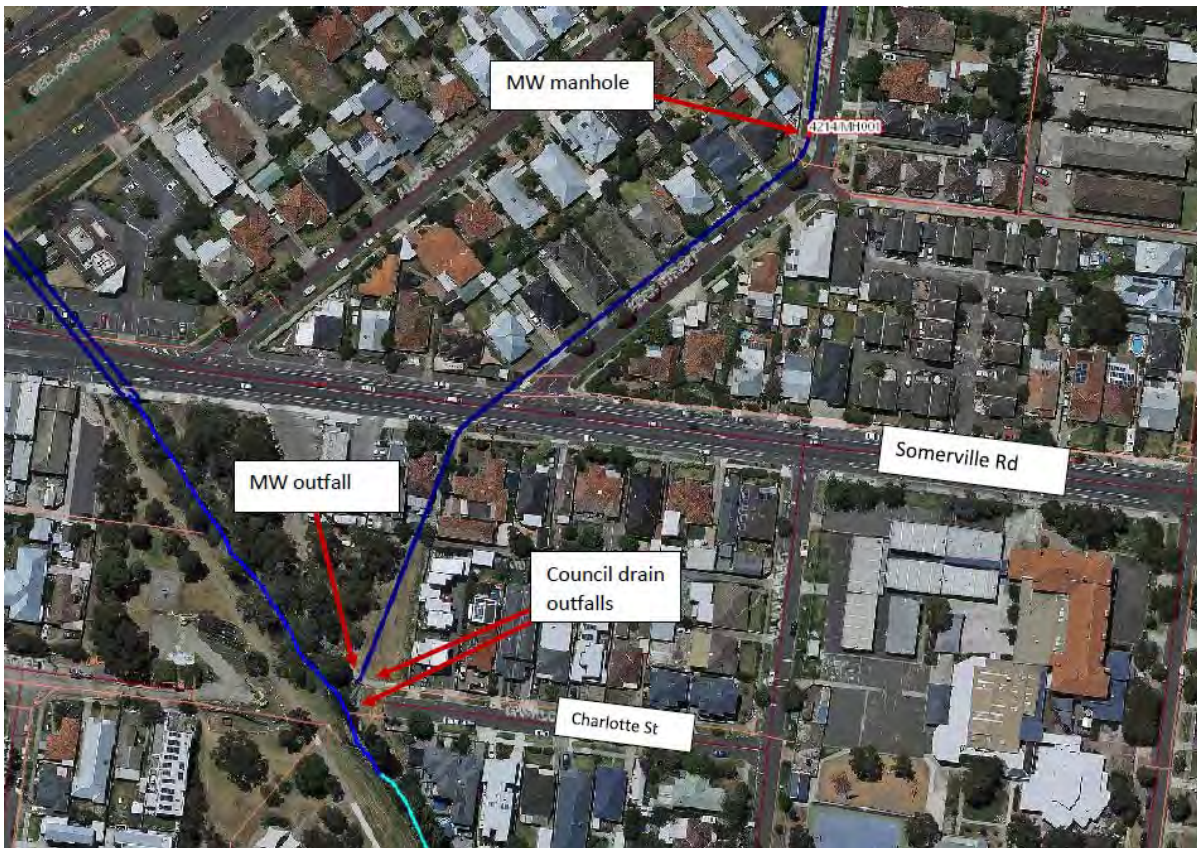
Figure 12 Location of manholes and drain outfall at Charlotte St.

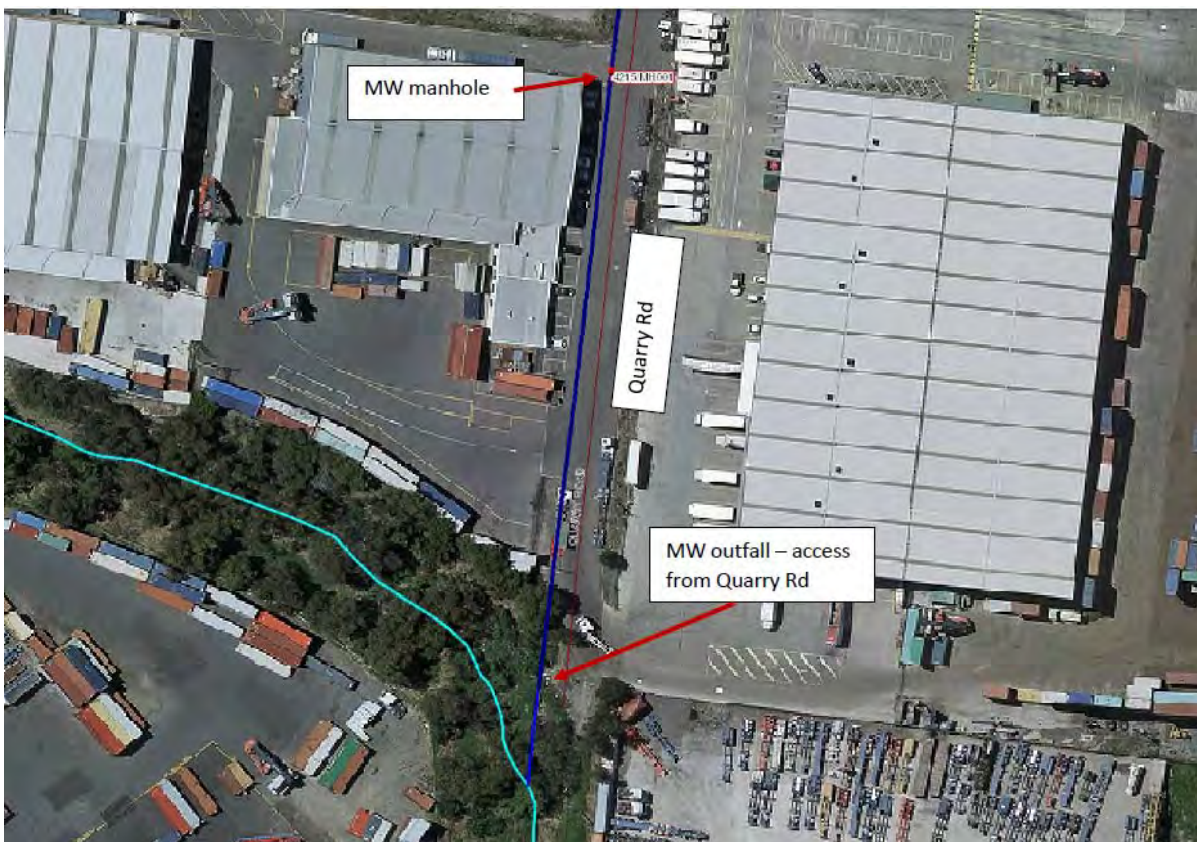
Figure 13 Location of manhole and drain outfall at Quarry St.

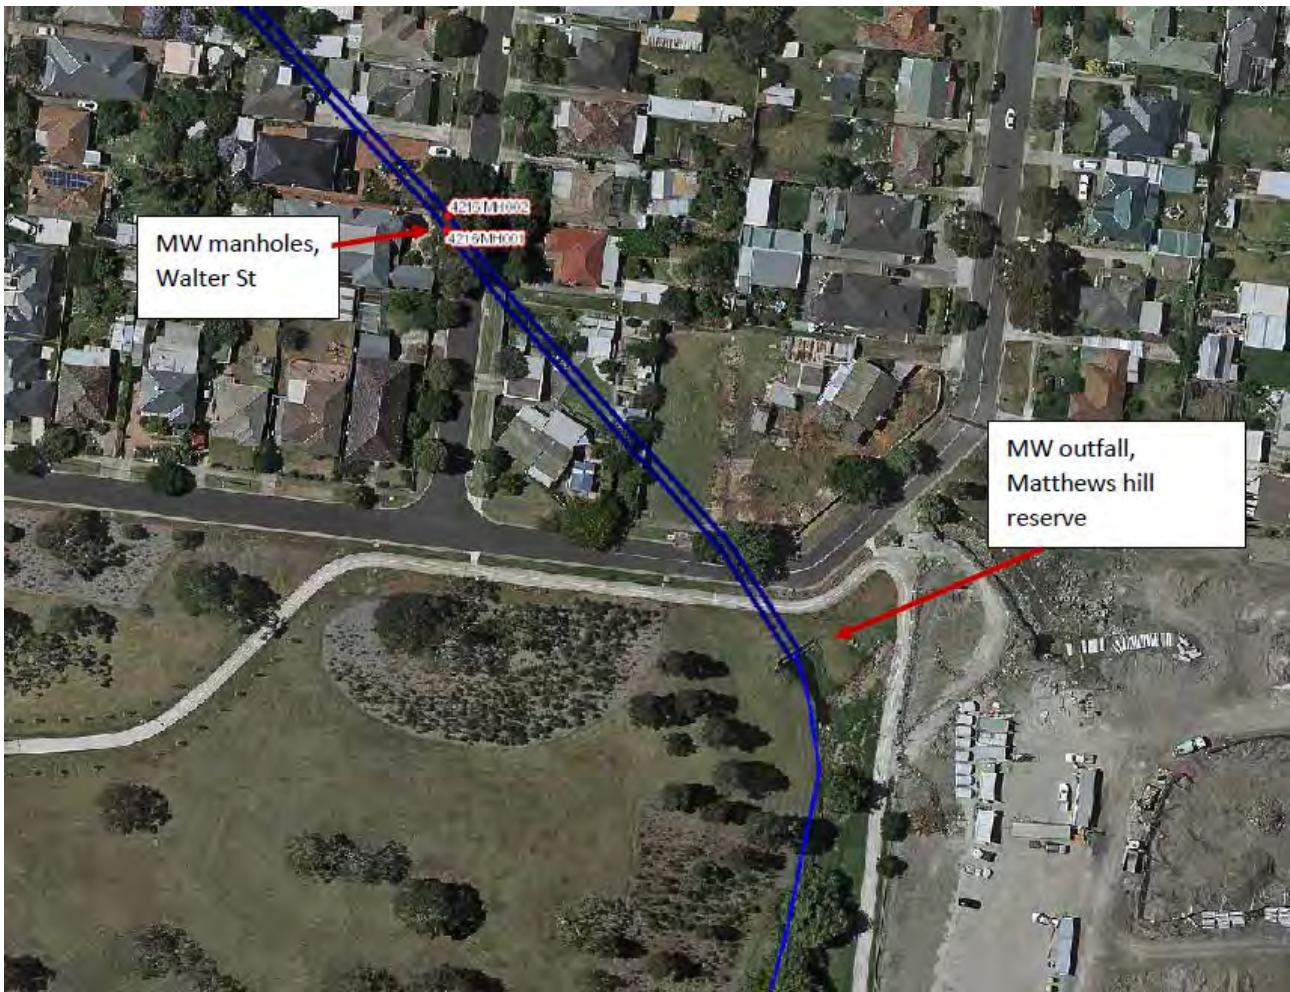
Figure 14 Location of manholes and drain outfall at Matthew's Hill Reserve. Manholes are located in Walter St.
