Coliban Water Monitoring Program

Monitoring Program for Assessing the Benefits of Environmental Offsets on the Condition of the Campaspe River: Year 1 (2018-2019)

Technical Report #22
December 2019

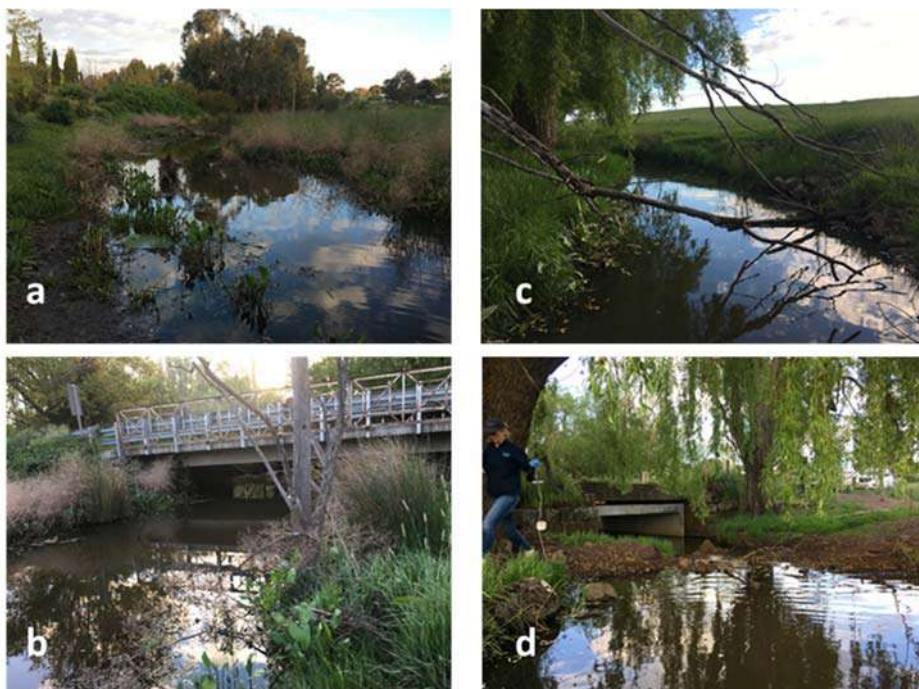
Plate 2: Study sites situated on Tributaries a) and b) Site 5, Post Office Creek, Wedge St., Kyneton; c) and d) Site 8, Snipes Creek, Barbow Rd.

Site 5 is situated in Post Office Creek, which is a small urban creek in the Kyneton township (Figure 2). The site is situated upstream of SFMW site D. Land-use surrounding the site is predominately urban residential and industrial. The riparian zone ranges in width from 1-4m and consists mostly of grasses and tussocks, with some small shrubs and larger trees (Plate 2 a and b). Several macrophytes occur within the shallows of the creek's banks including *Alisma* sp., *Lemna* sp., *Rumex* sp., sedges and rushes.

Site 8 is situated in Snipes Creek, a small creek which enters the Campaspe downstream of Site 7 (Figure 2). Land-use surrounding the site is farming. The riparian zone is between 1-2m in width and consists of grass and tussocks with several willows. Stock have unrestricted access to the creek at this site (Plate 2 c and d). Small amounts of *Persicaria* Sp., *Vallisaria* Sp., and *Rumex* sp. occur in the creek.

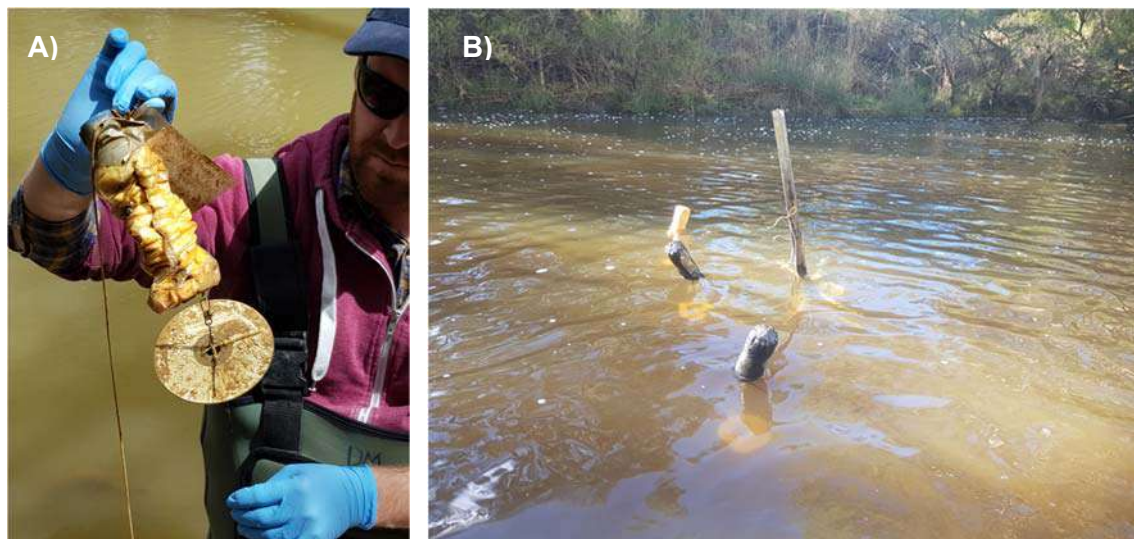
Plate 3: Artificial substrate Samplers (A) and (B) during deployment

Artificial substrates, thin disks suspended within the water column (Plate 3), were deployed at each of the 10 sites on two occasions (November 2018 and July 2019), for assessment of algal biofilm production. Artificial substrates were deployed for a 4-week period, allowing adequate time for biofilm colonisation. Following deployment, artificial substrates were analysed for biofilm biomass (biomass of algae, cyanobacteria, heterotrophic microbes and detritus), photosynthetic health (photosynthetic efficiency) and community composition.

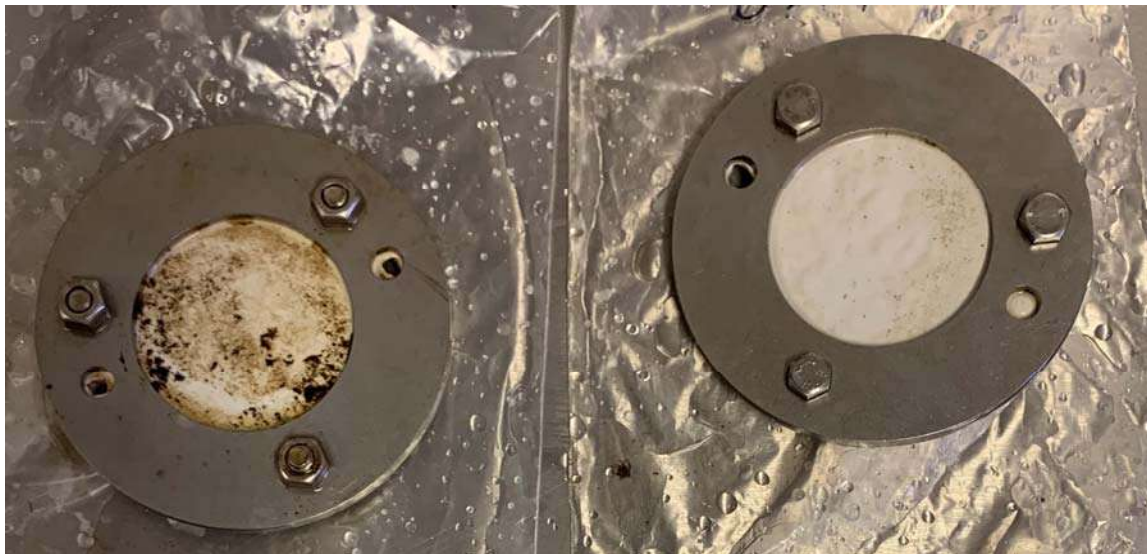
Plate 6: POCIS passive samplers following retrieval

Testing for the presence of other pollutants, including personal care products (PPCP), pharmaceuticals, herbicides, insecticides and pesticides occurred in surface waters (see Appendix 2 for full list), involving the deployment of Polar Organic Chemical Integrated Samplers (POCIS) (Plate 5 and 6). POCIS passive samplers were deployed at each of the 10 sites on one occasion (July 2019) for a 4-week period.

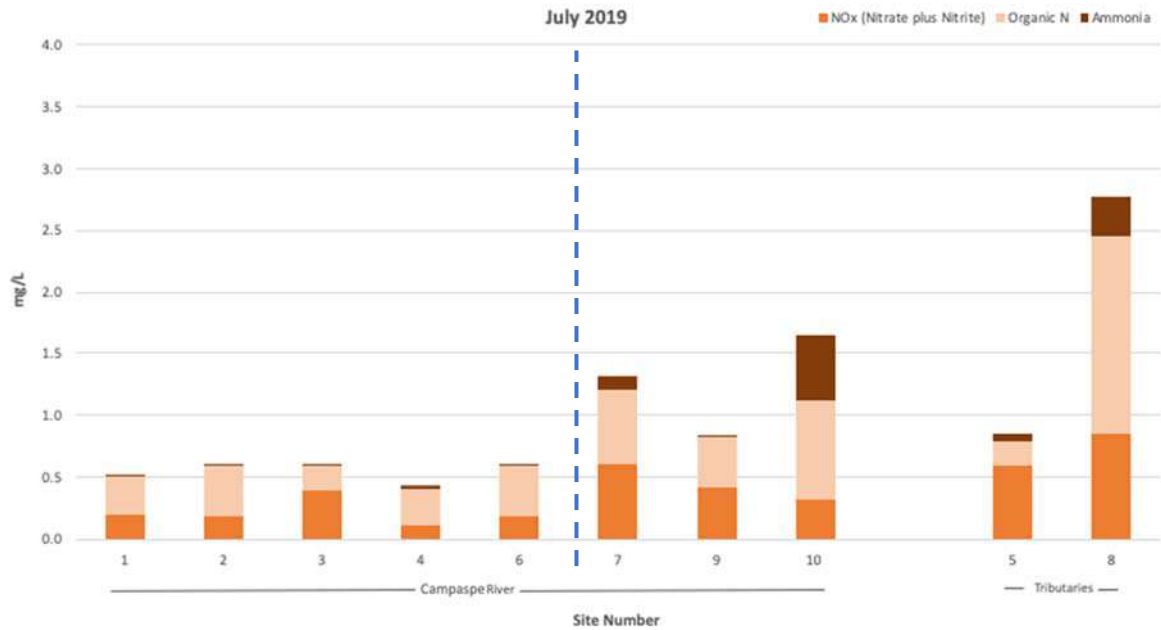
Figure 4: Mean nitrogen concentrations in surface waters during (a) September 2018, (b) October 2018, (c) November 2018, (d) December 2018 and (e) July 2019. Blue dashed line indicates Kyneton WRP discharge point between Sites 6 and 7.

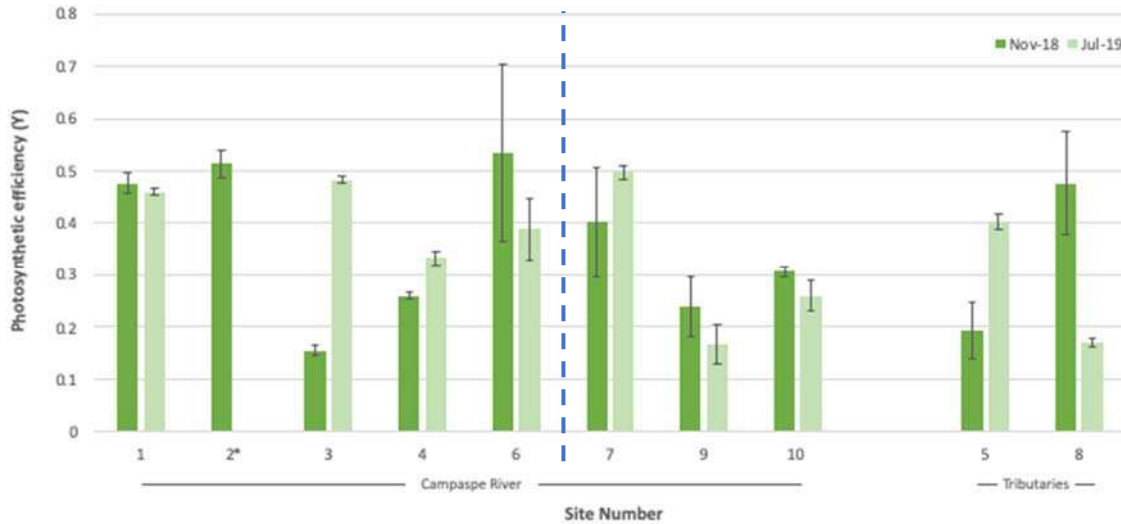
Figure 12: Mean photosynthetic efficiency (Fv/Fm) (±SE) of biofilms on artificial substrates deployed across sites during November 2018 and July 2019. Blue dashed line indicates Kyneton WRP discharge point between Sites 6 and 7.

In addition, the photosynthetic health (photosynthetic efficiency) and community composition of the biofilms, observed on the artificial substrates, was also measured (Figures 12 and 13). Photosynthetic efficiency (Y) differed significantly between sites in November 2018 (Kruskal-Wallis, $H= 22.172$, $DF= 9$, $p=0.008$) and July 2019 (Kruskal-Wallis, $H= 22.951$, $DF= 8$, $p=0.003$) (Figure 10), with differences between time points within a site seen at Sites 3, 4, 5 and 8. Within sites, lower values were observed in November 2018 at Sites 3, 4 and 5, with the opposite observed at Site 8, indicating a reduction in photosynthetic health.

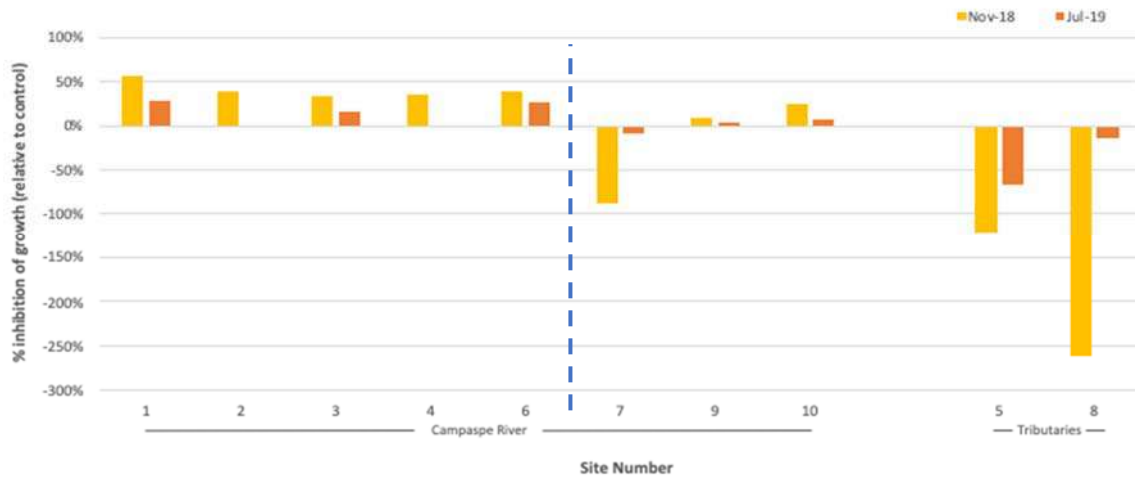
Figure 14: Percent inhibition of algal growth (relative to site control) across sites during November 2018 and July 2019. Blue dashed line indicates Kyneton WRP discharge point between Sites 6 and 7.

Differences in algal growth (biomass) between control and exposed algal balls were examined at each site during November 2018 and July 2019 (Site 2 was not measured in July 2019 due to access issues) (Figure 14). Exposed algal balls were compared to the control to determine if exposure to site conditions inhibited or encouraged growth. Positive values indicate inhibition, with 0-20% minimal impact, 20-50% moderate impact and >50% significant impact. Negative values indicate increases in biomass, suggesting that site conditions (e.g. high levels of nutrients) are encouraging growth. In November 2018, percent inhibition relative to the control ranged from 9 to 56%, with increases in growth observed at Sites 5, 7 and 8. In July 2019, percent inhibition relative to the control ranged from 0 to 28%, with increases in growth observed at Sites 5, 7 and 8.
