A3P Project: Stony Creek whole of system litter investigation & management prioritisation

Targeted Litter Surveys Summary Report

Technical Report No: 56

February 2022

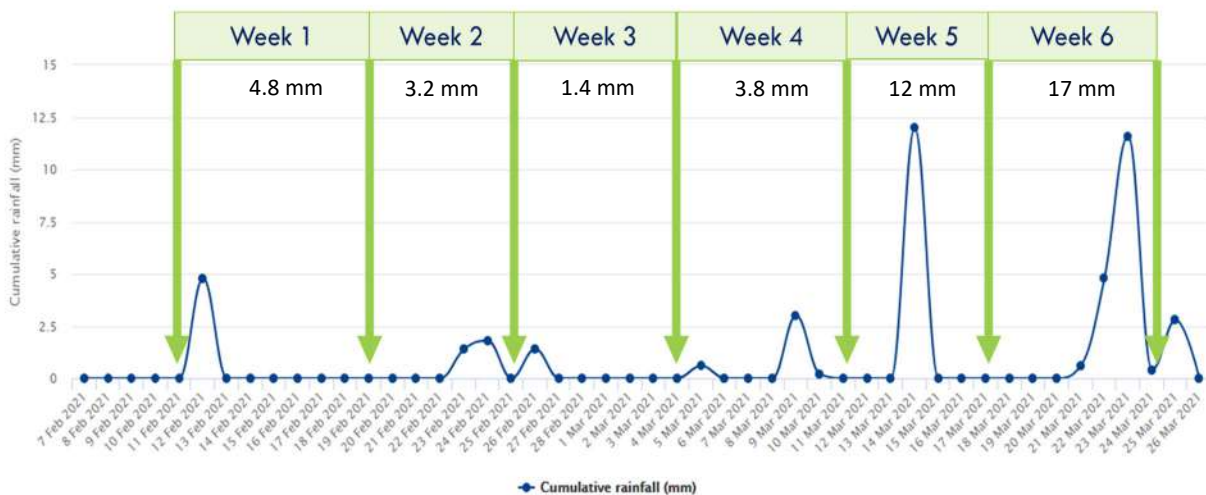
Figure 4: Cumulative (blue line) and total rainfall at Spotswood during storm drain surveys.

Rainfall during the stormwater drain survey period is shown in Figure 4. During weeks 1-4 small rainfall events occurred with total rainfall ranging 1.4-4.8 mm. During weeks 5 and 6 two significant storm events occurred resulting in total rainfall of 12 and 17 mm in each week respectively (Figure 4). This indicates that flow in Stony Creek during the first 4 weeks of sampling is representative of dry weather flows, while weeks 5 and 6 are representative of storm event flows (Figure 4).

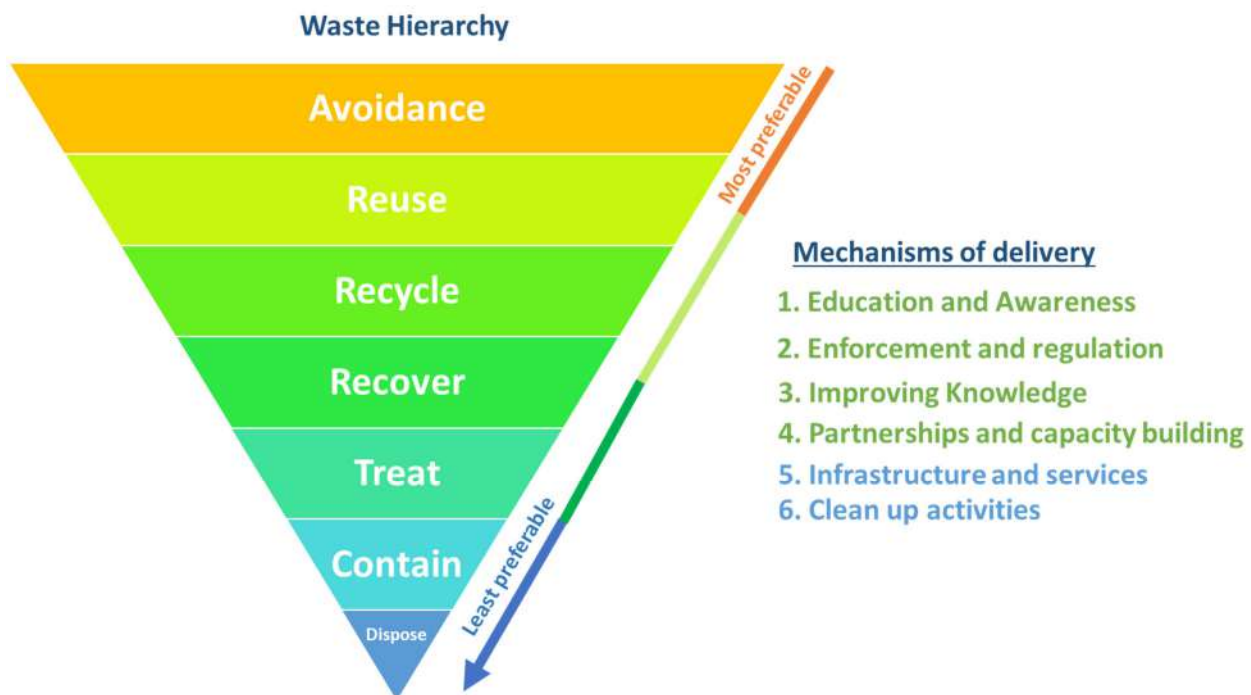
Figure 18: Mechanisms of delivery for litter management and the waste management hierarchy. Mechanisms of delivery in green are focused on prevention and reuse, while those in blue are treatment and disposal-based options.

There are a broad range of options for managing litter which fall into six main mechanisms of delivery, ranging from prevention-based options, such as education and awareness programs, knowledge building, partnerships and capacity building, and enforcement and regulation to infrastructure-based solutions such as installation of litter traps or bins and clean-up activities. Preferably higher priority would be given to actions to reduce and manage litter at the source, as this minimises environmental impact, with lesser priority given to actions that have lower environmental benefit such as treatment or litter disposal as outlined in the waste hierarchy (Figure 18). However, often an integrated approach is necessary as currently litter cannot be effectively managed by prevention-based actions alone.

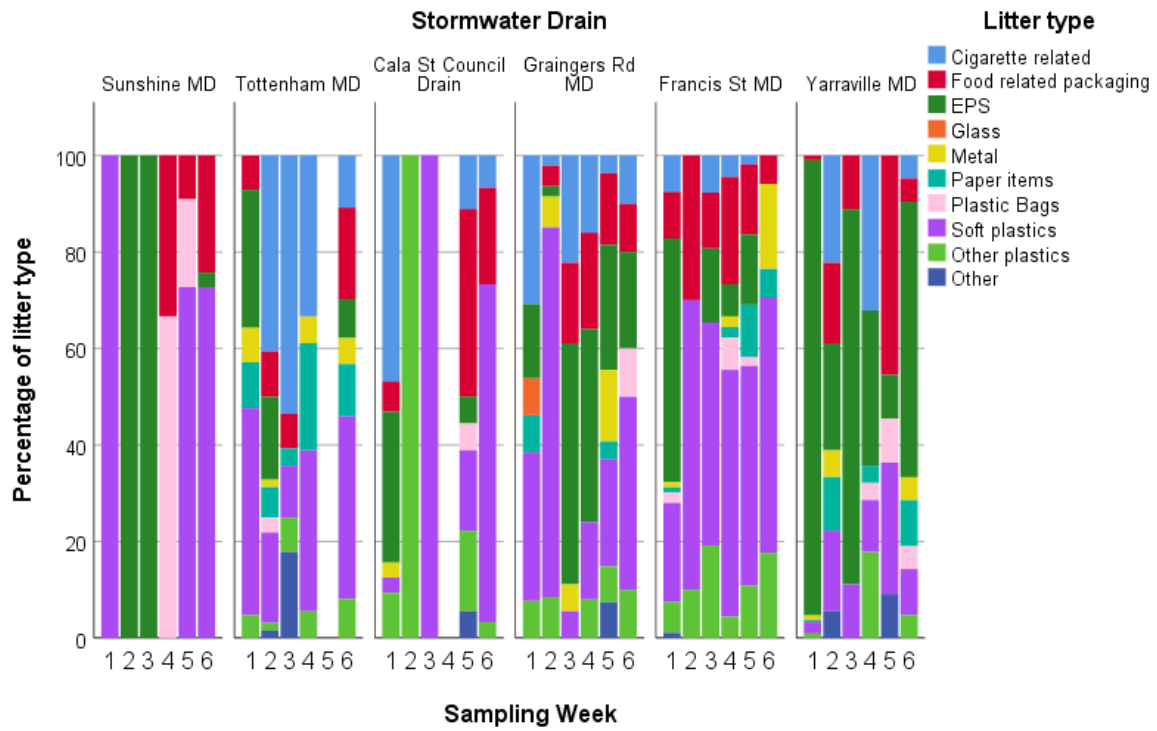
Figure 19: Composition of litter captured from stormwater drains according to sampling week.
